## ASBESTOS MANAGEMENT SURVEY REPORT

**SITE ADDRESS:** Former public conveniences, St Albans Road, Clacton On Sea

| Survey Date: | 13 Oct 2026 |

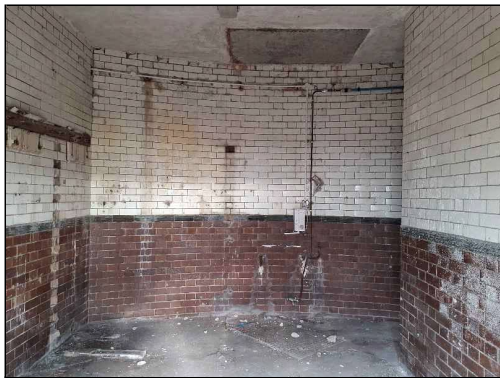
| MATERIAL ASSESSMENT / SAMPLE IDENTIFICATION REPORT | | | |
|---|---|---|---|
| Level | Ground Floor | Description | No suspect materials found |
| Action Required / Control Recommendation | No further action required | | |

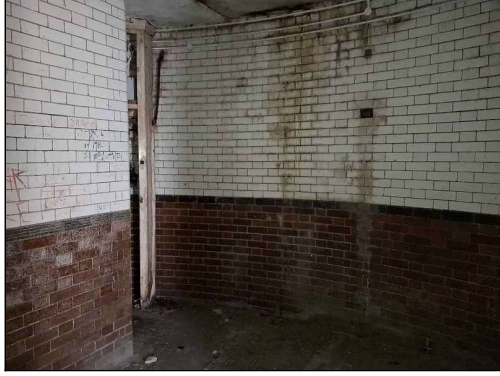
| MATERIAL ASSESSMENT / SAMPLE IDENTIFICATION REPORT | | | |
|---|---|---|---|
| Level | Ground Floor | Description | No suspect materials found |
| Action Required / Control Recommendation | No further action required | | |

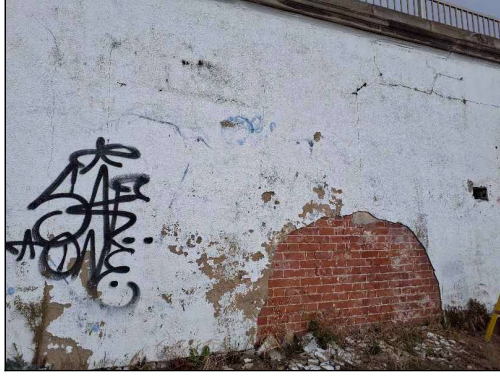
| MATERIAL ASSESSMENT / SAMPLE IDENTIFICATION REPORT | | | |
|---|---|---|---|
| Level | External | Description | No suspect materials found |
| Action Required / Control Recommendation | No further action required | | |
