Brightlingsea Conservation Area Character Appraisal and Management Plan

Tendring
District Council

Date:
November 2023

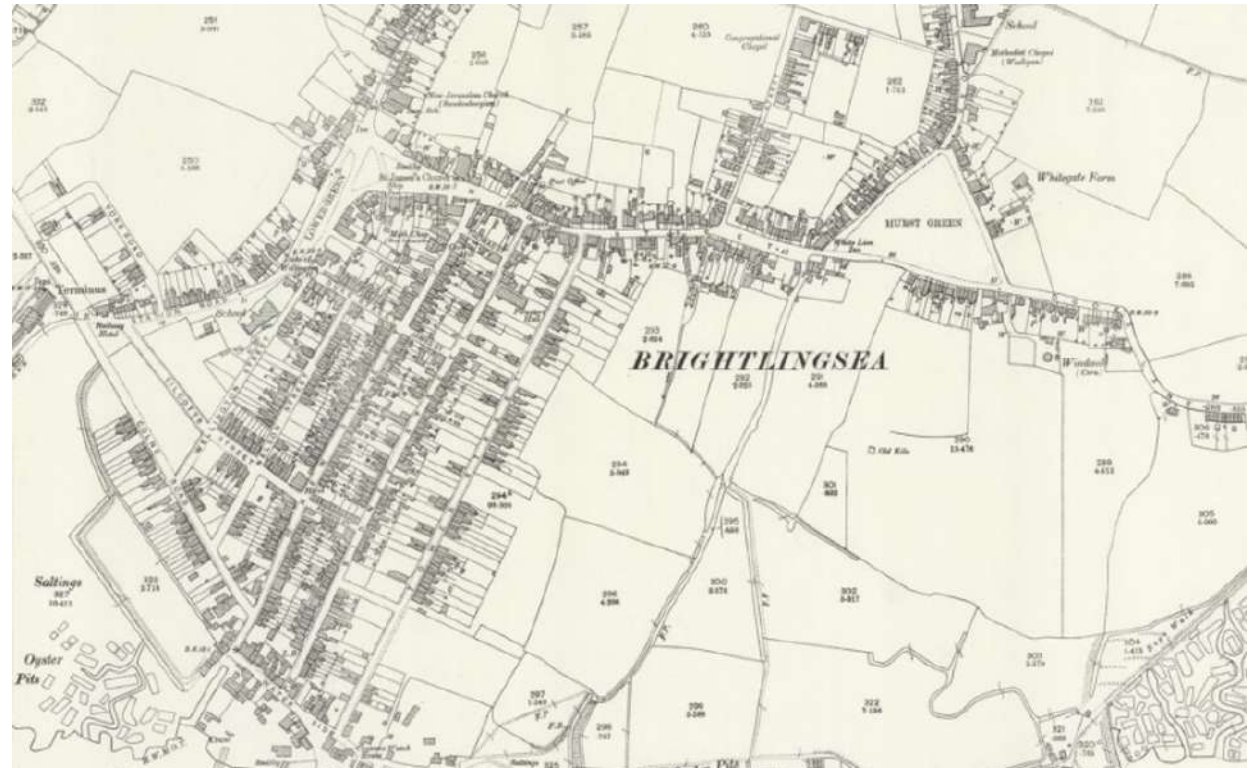
Figure 8 Ordnance Survey Map 1897

During the late nineteenth and early twentieth century, further expansion of the town took place. This expansion is demonstrated on the Ordnance Survey Map of 1897 (Figure 8), with development along Colne Road, Wellington Street, Nelson Street, Silcott Street, to the west side of New Street and along Tower Street. This rapid influx of residential terraced houses demonstrates the population growth of Brightlingsea at this time. Further terraced houses also appear on Station Road and York Road, close to the station.

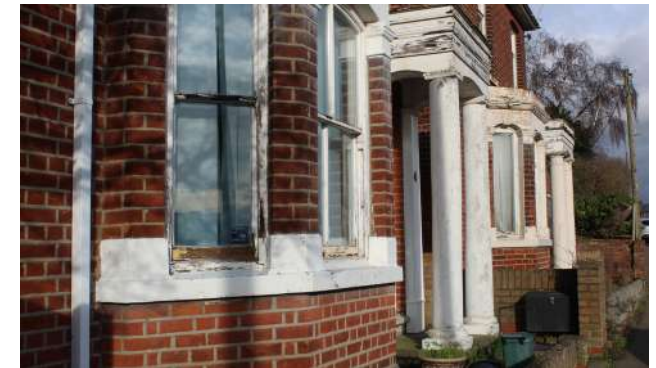
Figure 25 Architectural detailing of houses on Hurst Green

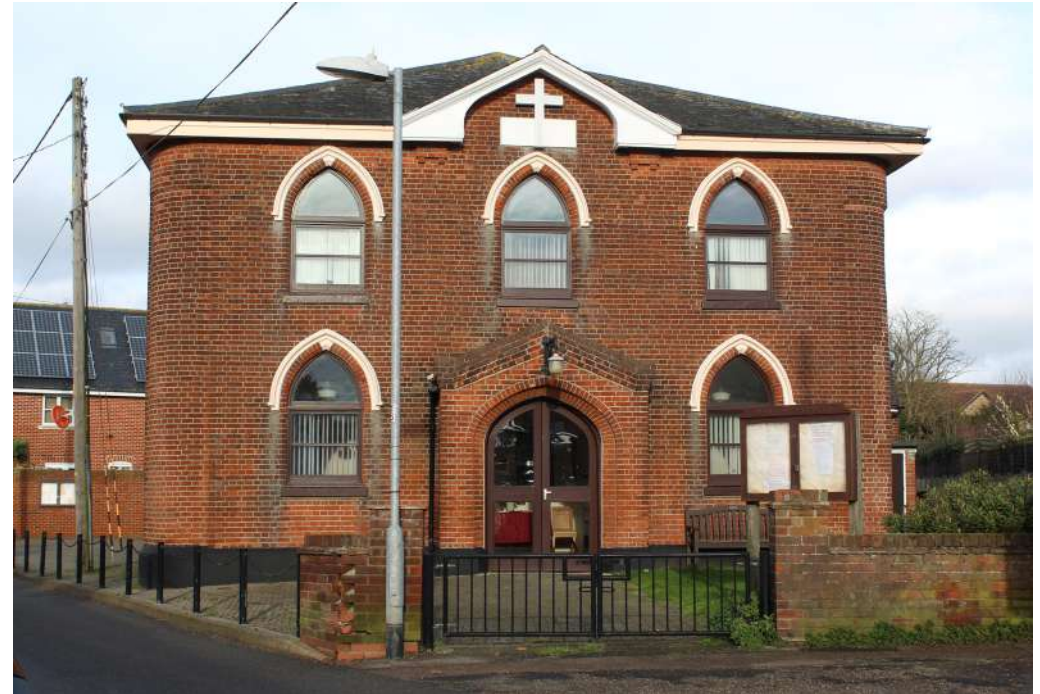
Figure 29 Detail of the United Church (Methodist U.R.C.)

The Chapel is a prominent building on Chapel Road and makes a positive contribution to the area. It is red brick with arched windows and a pedimented porch and roof. Its corners are curved, adding architectural interest to the building. The size and orientation of the building set it apart from others within the area.

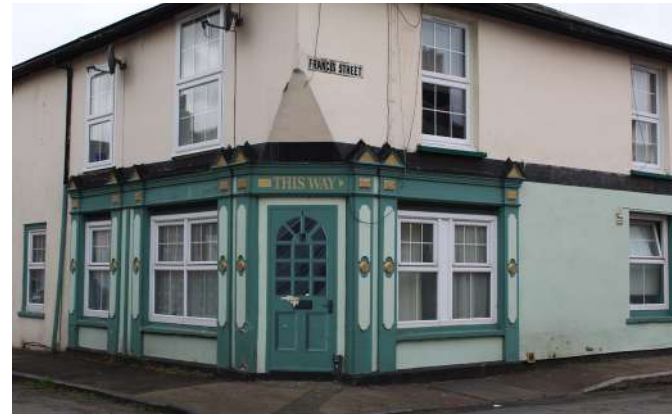
Figure 46 Historic shopfront on Sydney Street

Continuing south along the street, buildings are predominantly two-storey residential dwellings in red brick or painted render. Many have retained original architectural detailing, which add to their interest and contribute positively to the area, and there are examples of historic shopfronts on the corner with Francis Street (Figure 46). There are also

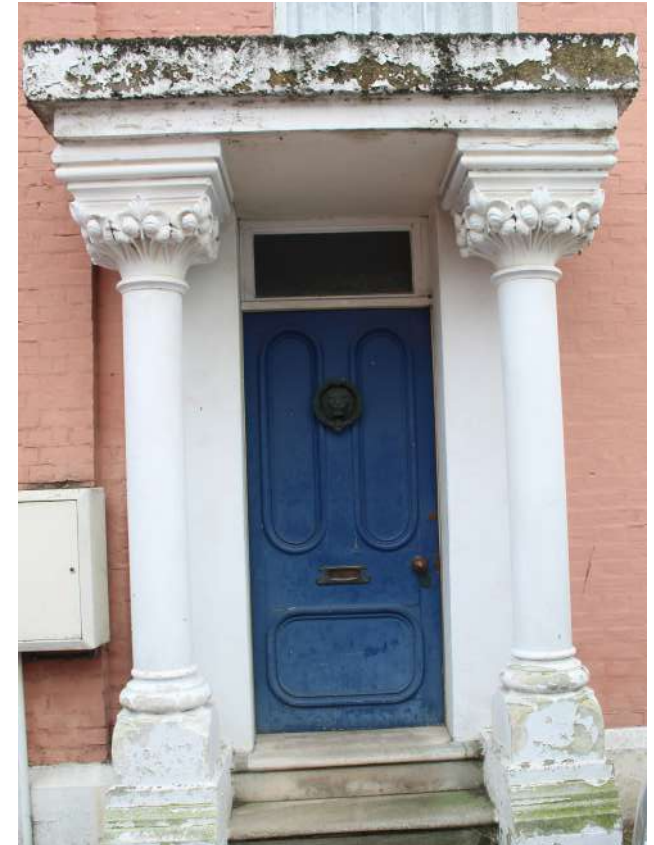
Figure 54 Ornate historic detailing

The local details within this area are often simple in their architectural style and material. Minor detailing such as brick banding, stone windowsills and keystones are common. There are also some classical doorframes, and in some larger buildings typically Georgian details such as columns can also be found.

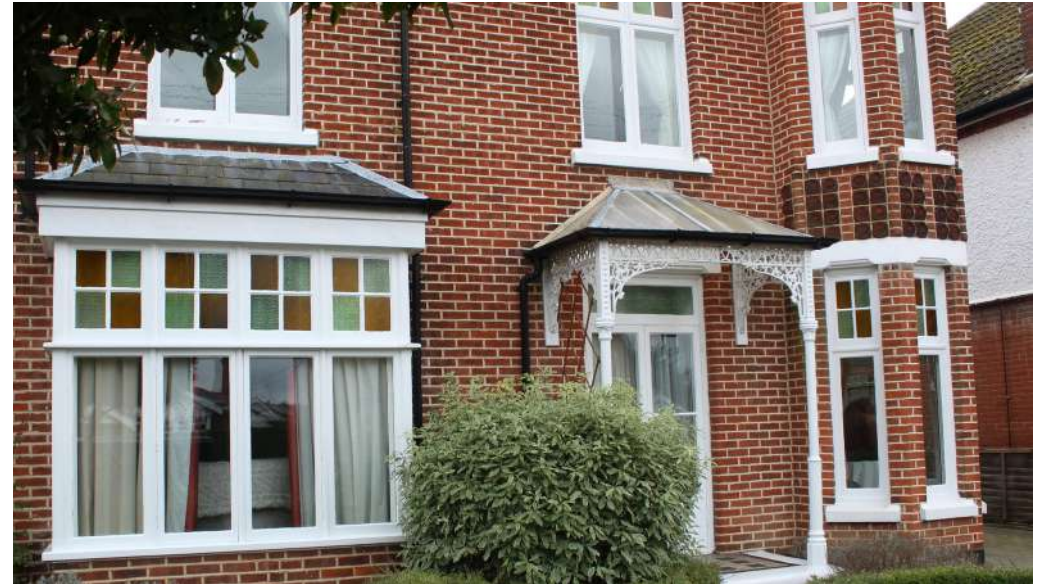
Figure 74 Number 40 Regent Road

Number 40 Regent Road is notable and makes a positive contribution to the streetscape. It has interesting original decoration, including windows with stained glass panes, a porch canopy, decorative barge boarding and other architectural elements such as the turret with pyramid roof which contributes positively to the architectural interest of the building.

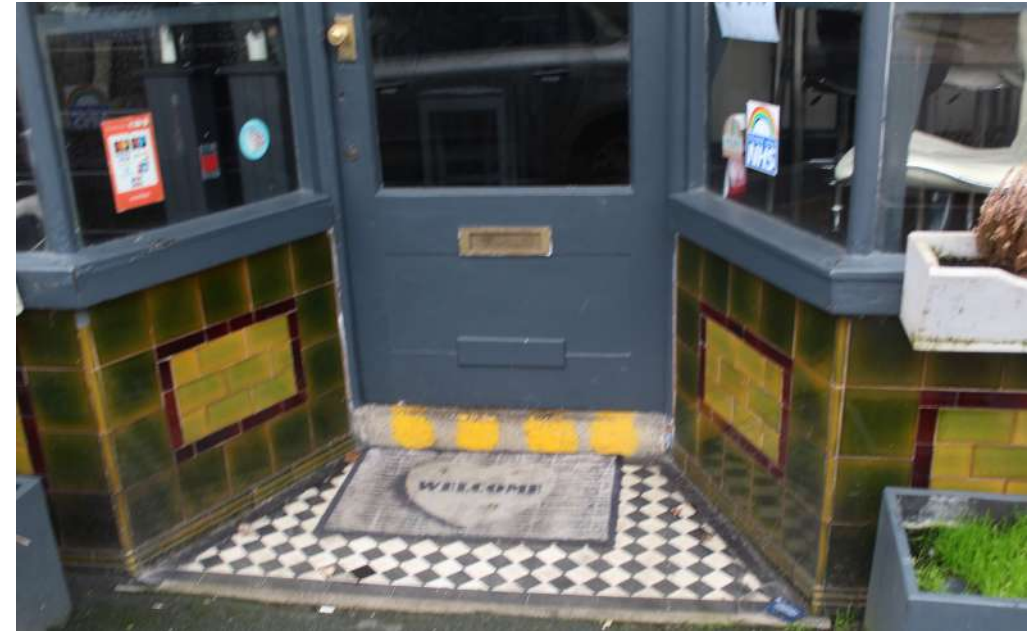
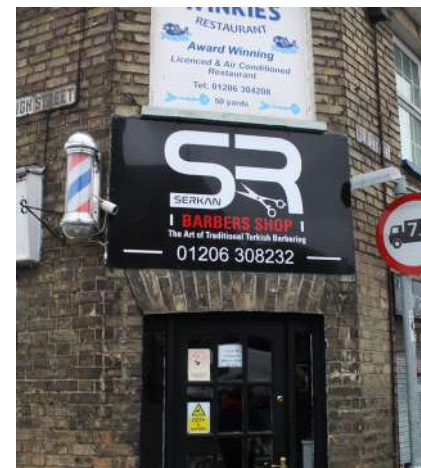
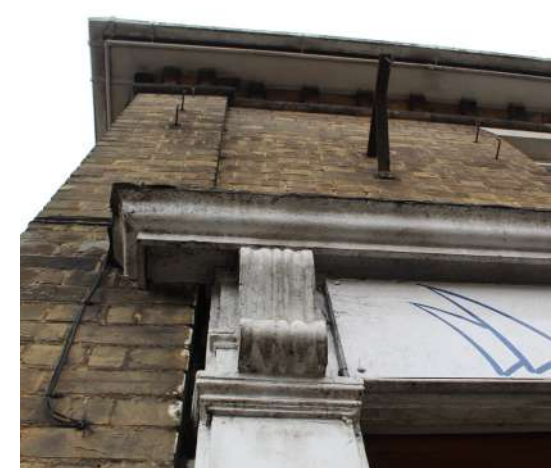
Figure 84 Clockwise from top: Porch and tile detailing, historic shopfront detail and modern signage
